(Final Report, Revised October 2, 2025)
**Condition Assessment
&
Reserve Fund Plan Update
2025**

VILLAGES OF PIEDMONT
Haymarket, Virginia

RE: **CONDITION ASSESSMENT AND RESERVE FUND PLAN UPDATE 2025**
Villages of Piedmont Homeowners Association
(Final Report, Revised October 2, 2025)
Haymarket, Virginia
Project No. 10300

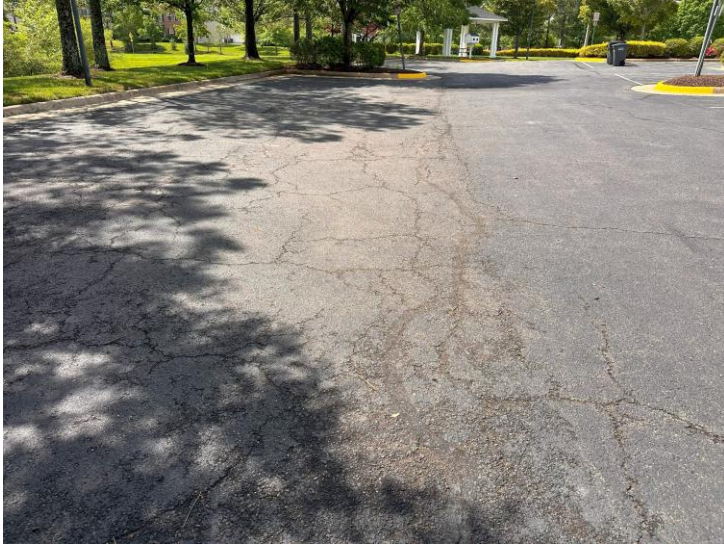
Photo #1

The community center parking lot is in very poor condition despite having been maintained. We observed wide-area deflective cracking and significant transverse and lateral cracking. We have scheduled restoration for 2026.

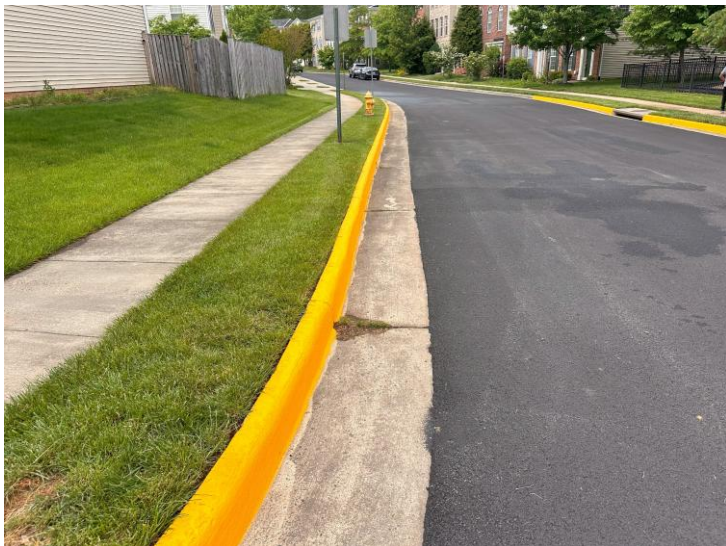
Photo #2

The townhome asphalt has been fully restored in 2025 and is in excellent condition. Significant repairs to the sidewalks, curbs and gutters, and driveway aprons were also executed contemporaneously. Management provided the invoices for these projects, which have been used in our calculations.

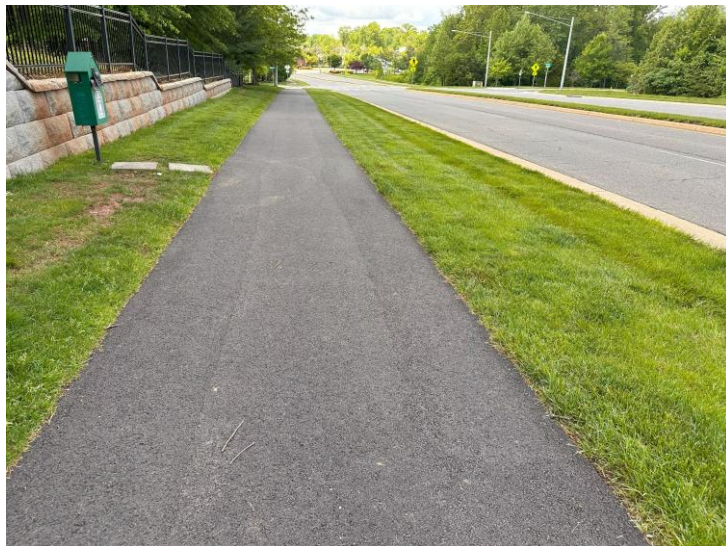
Photo #3

The asphalt footpaths have also been restored and are in excellent condition with only a few minor deficiencies observed.

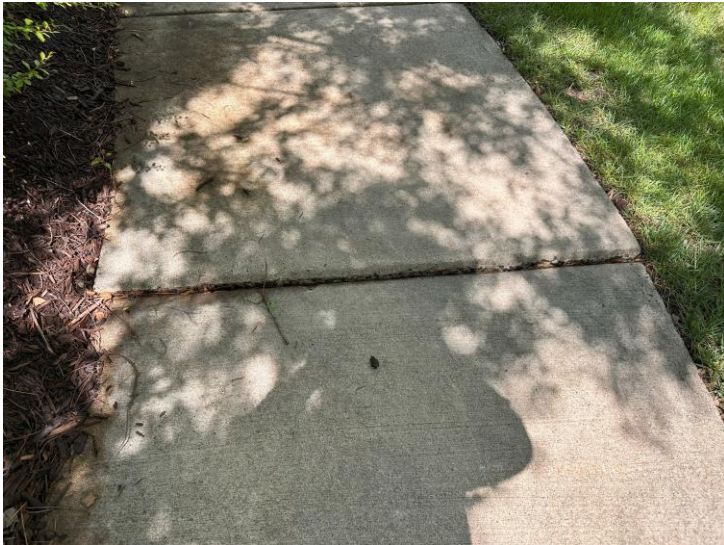
Photo #4

Management reported that the sidewalk deficiencies around the community center were addressed after the site evaluation for a cost of \$14,000. We used this cost in our calculations.

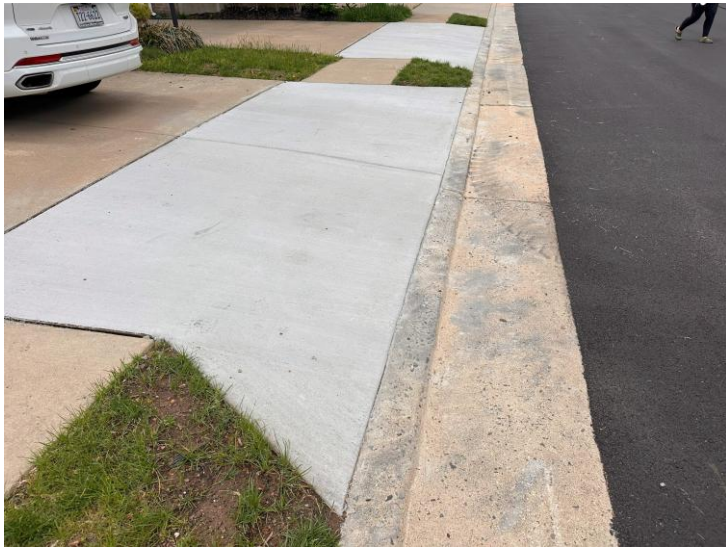
Photo #5

The townhome concrete repairs totaled approximately \$117,000 and addressed approximately 2,660 square feet of sidewalk, 5,444 square feet of driveway apron, and 488 linear feet of curb and gutter. The community should be congratulated on this accomplishment.

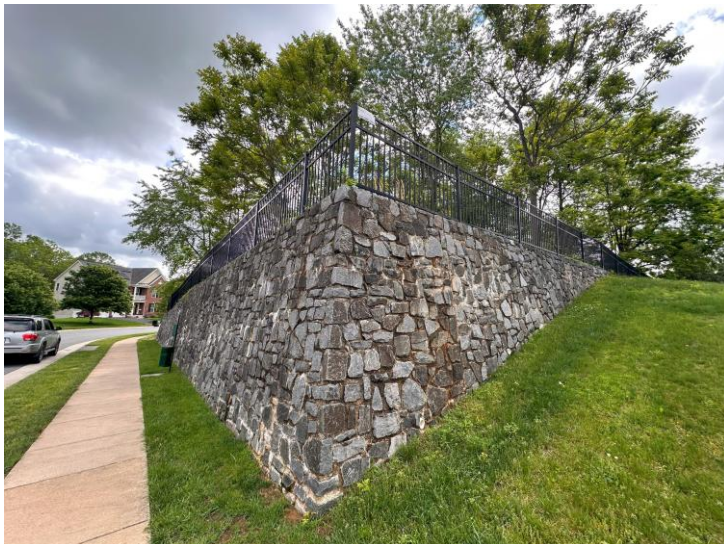
Photo #6

The retaining walls and railings are in excellent condition. A few localized areas of damaged fencing were observed due to falling limbs but none of the damage is significant and no remediation is required at this time.

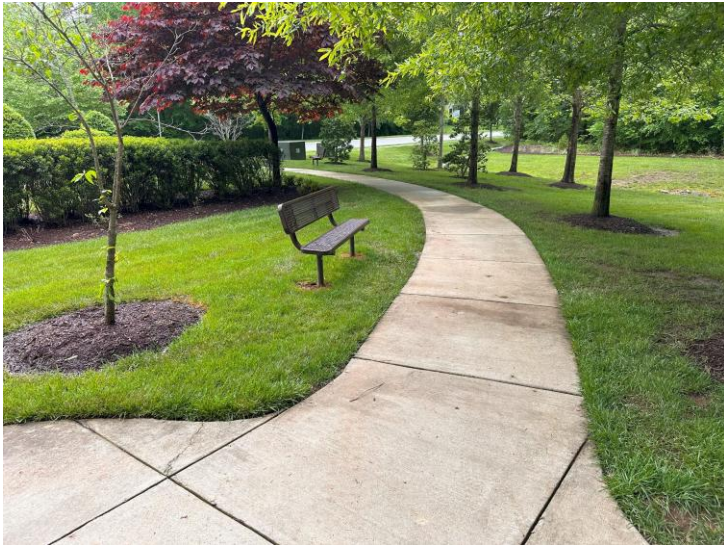
Photo #7

The park at the entrance to Leopold's Preserve was constructed since the previous evaluation and we have updated the inventory to include the sidewalks, benches, bike racks, brick bollards, and wooden fencing. No deficiencies were observed throughout any of these components.

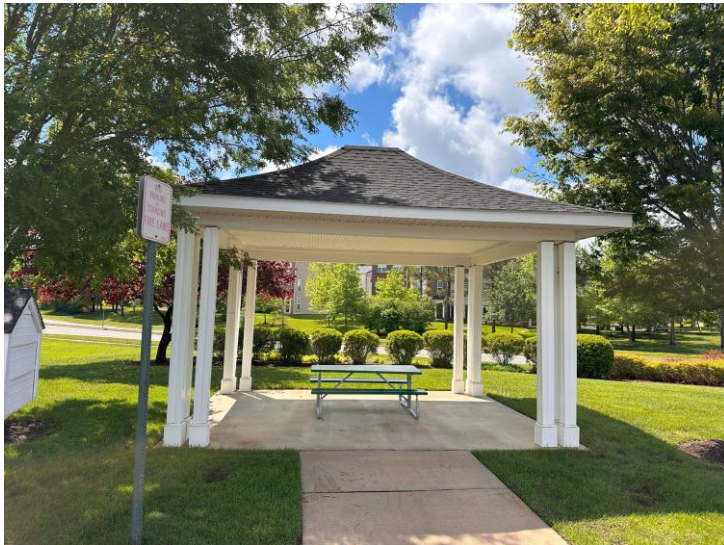
Photo #8

The three picnic pavilions are in improved condition relative to the previous evaluation. We observed some minor deficiencies none of which require remediation at this time. The inventory has been updated to include the grills ash receptacles and picnic tables.

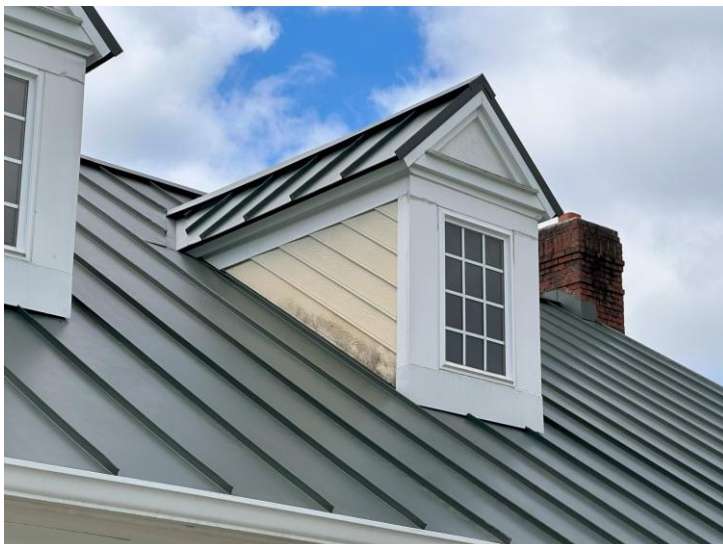
Photo #9

The original asphalt shingle roofing has been replaced with coated standing seam metal roofing which is in excellent condition. This is a significant improvement, and the new roofing should provide a very long service life. As the roofing ages and rust appears the roofing should be recoated under operations.

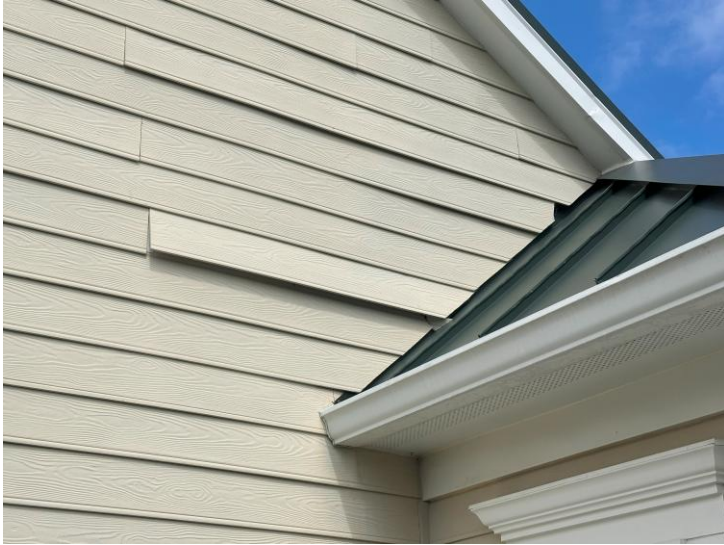
Photo #10

The building facades are in excellent condition. However, we observed one section of damaged and detached fiber cement siding. This section should be repaired under operations to prevent water intrusion and further damage.

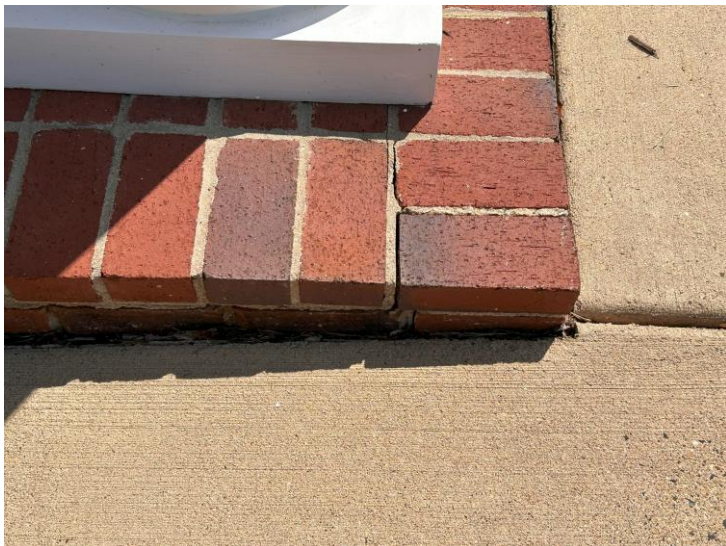
Photo #11

The brick tuck pointing throughout the building appears to be in excellent condition. This one area located on the western elevation of the front porch is the exception. These cracks should be routed and filled under operations to prevent water intrusion and further damage during freeze thaw events.

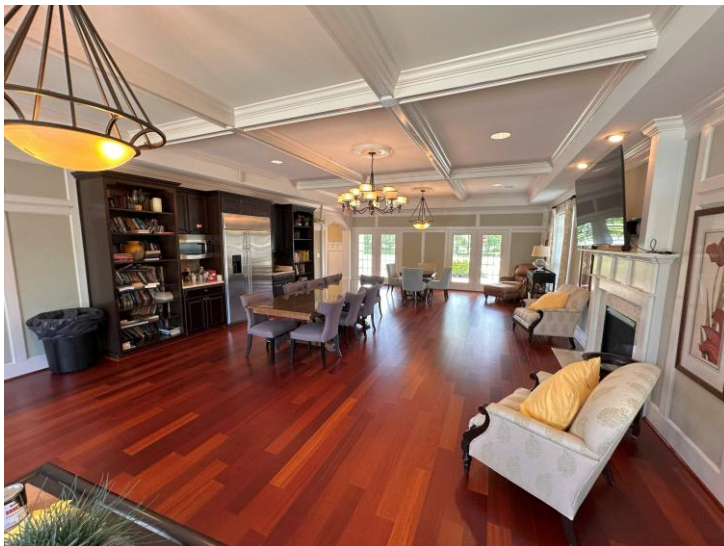
Photo #12

The community interiors are in excellent condition with no deficiencies observed. We have updated flooring quantities to reflect the removal of the carpet. No significant deteriorated furnishings or office equipment was observed or reported. Items should be replaced as needed but timing and cost is discretionary.

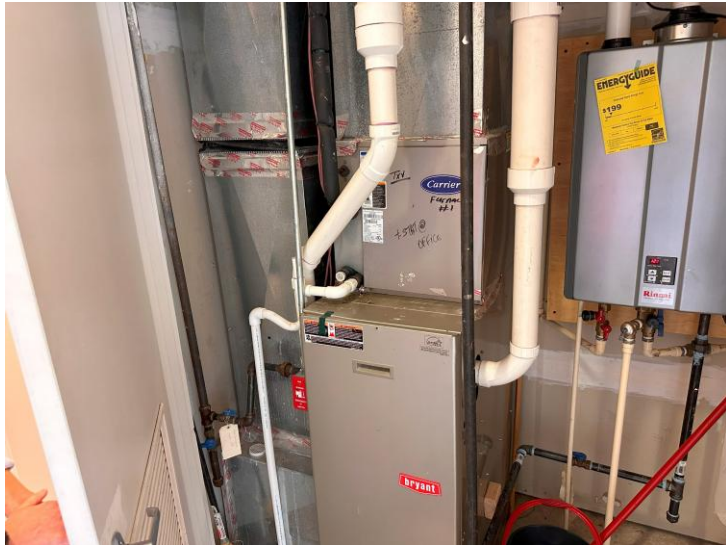
Photo #13

The mechanical systems are in good operating condition with no deficiencies observed or reported. The water heater was replaced in approximately 2023 but no information on the replacement project was able to be found.

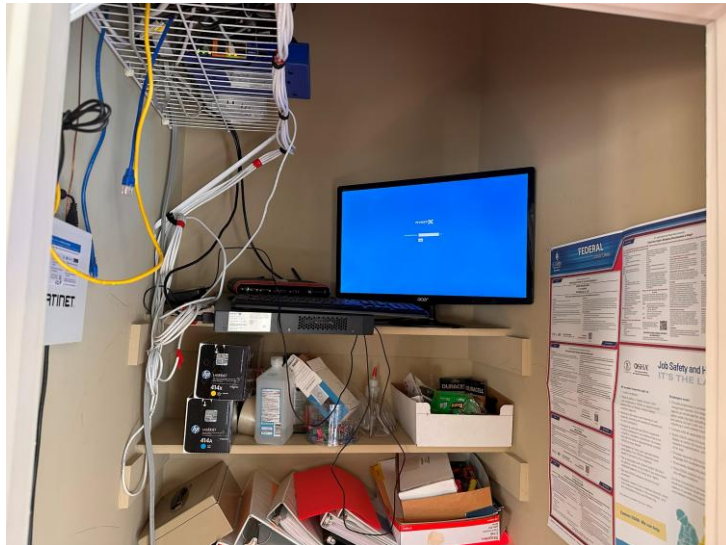
Photo #14

We have updated the inventory to include the surveillance system. We have provided an allowance for the upgrade and replacement of individual components on an as needed basis.

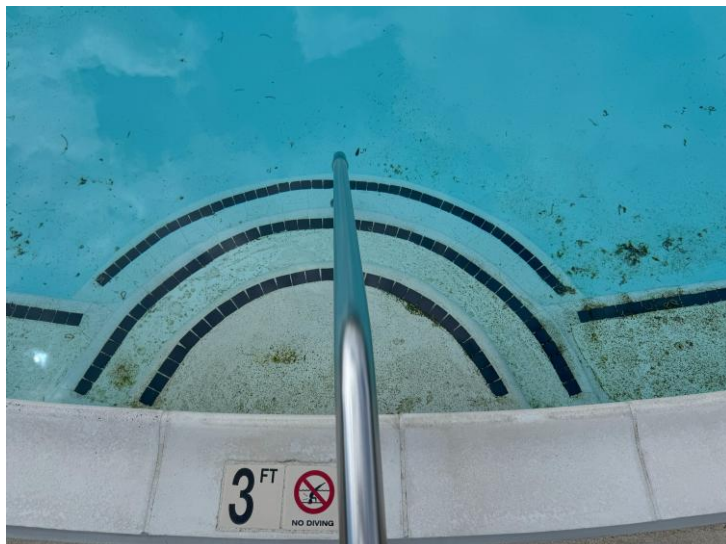
Photo #15

The pool structure was reported to be in good condition and received approximately \$10,000 worth of repairs recently, which included the re-bedding of approximately twenty-five coping tiles, the full replacement of the expansion joint, patching of the white coat, and the repair of pool lighting.

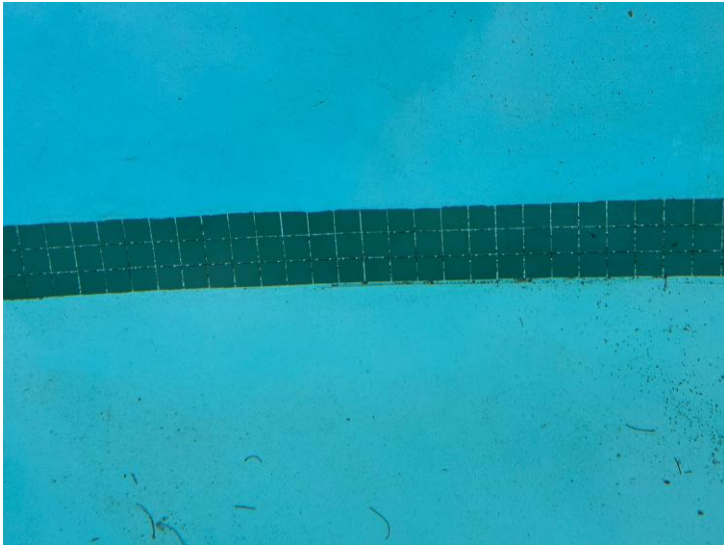
Photo #16

The pool white coat was observed to be in fair condition with moderate scaling and cracking. Additionally, we observed some eroded grout along the racing tile lines. We have scheduled a repair project near-term.

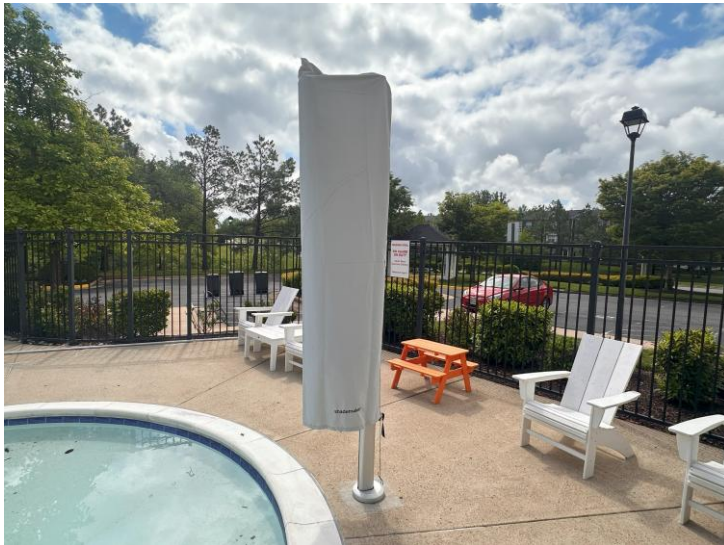
Photo #17

The ancillary pool equipment including umbrellas, pergola shelters, replacement pool furnishings (2023), lifeguard stand, and pull ladders are all in excellent condition with no deficiencies observed. The inventories have been updated appropriately.

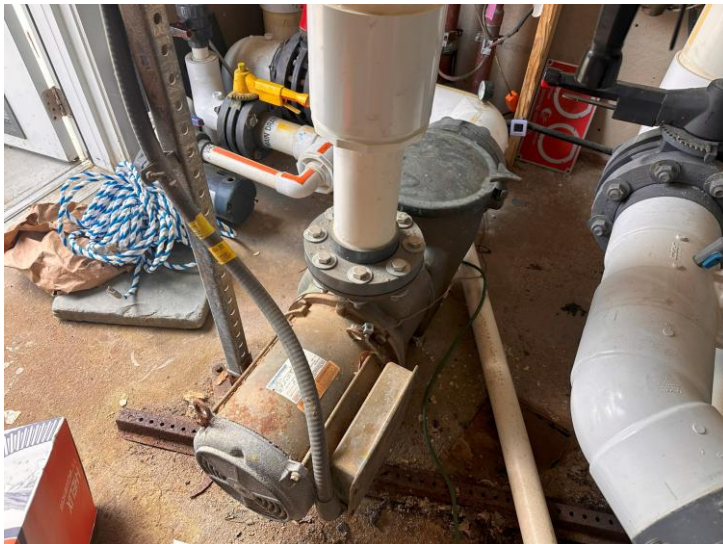
Photo #18

The pool mechanical equipment is in good condition, and no problems were reported. The main pool pump is original and has surpassed typical service life. However, no problems were reported so we have extended the service life by five years.

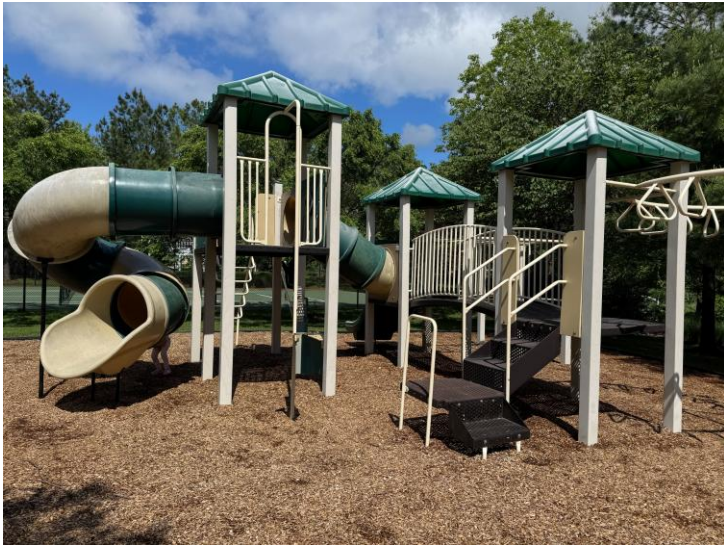
Photo #19

Both tot lots appear to be in generally very good condition. We understand that they are frequently inspected and maintained including the replacement of deteriorated hardware. We observed minor fading and typical wear, but the equipment is serviceable, and we have therefore extended the service life.

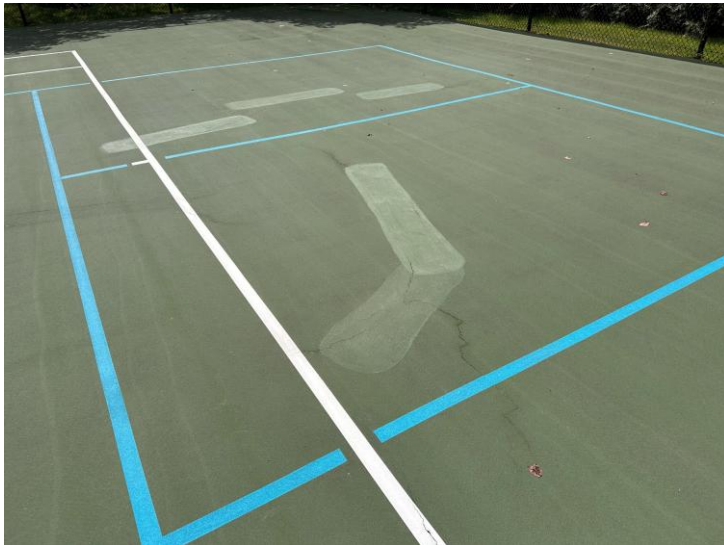
Photo #20

The tennis and pickleball courts are in poor condition but will be repaired and coated in June of 2025. Based on our observations and the age of the courts we have scheduled full replacement in 2030.

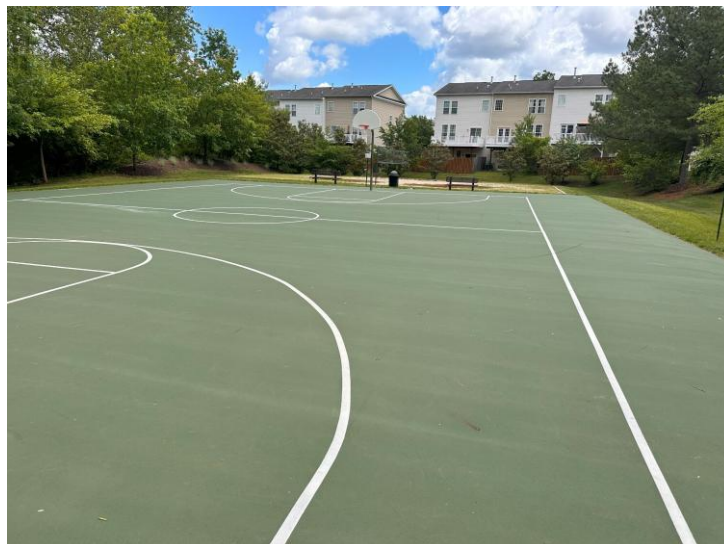
Photo #21

The basketball court is in excellent condition with no deficiencies observed. We understand that the court has been recently coated for a price of approximately \$17,000. Restoration has been scheduled after a typical service life. The basketball standards and goals are also in good condition.
